# Resistance to Fracture, Fatigue and Stress-Corrosion of Al-Cu-Li-Zr Alloys

A. K. Vasudevan, R. C. Malcolm,  
W. G. Fricke, and R. J. Rioja

Aluminum Company of America  
Alcoa Laboratories  
Alcoa Center, PA 15069

Final Report  
(Period: 1981 July 01 to 1985 February 28)  
Contract N00019-80-C-0569  
Department of the Navy  
Naval Air Systems Command  
Washington, D.C. 20361

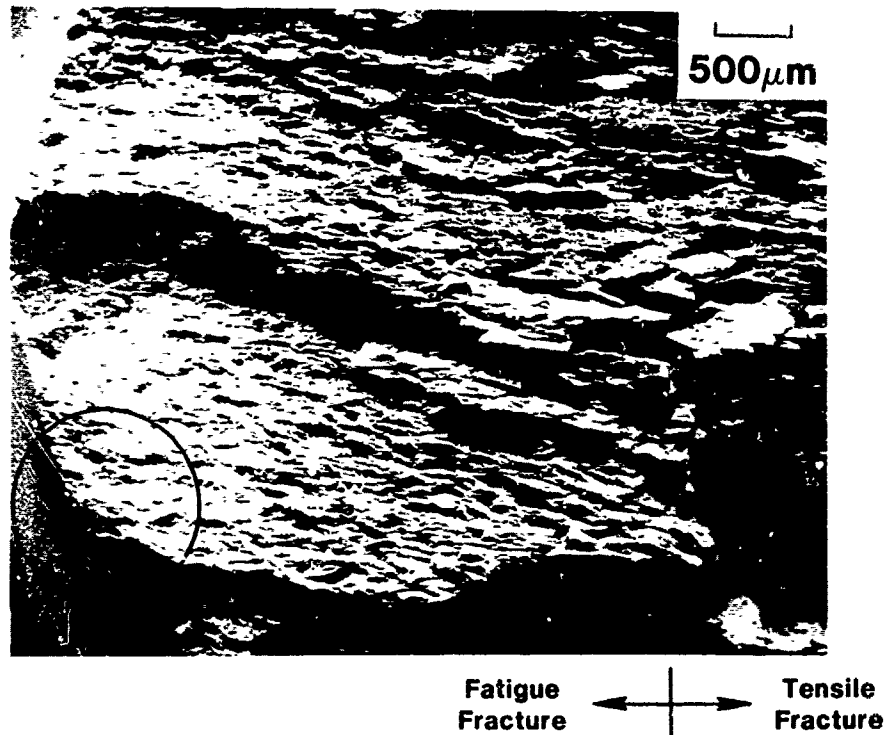
Figure 18

(a) SEM fractograph of a fracture surface (partial)  
of notched axial-stress fatigue specimen 548468-L-6  
(Al -1.1Cu -2.9Li alloy T651 plate)

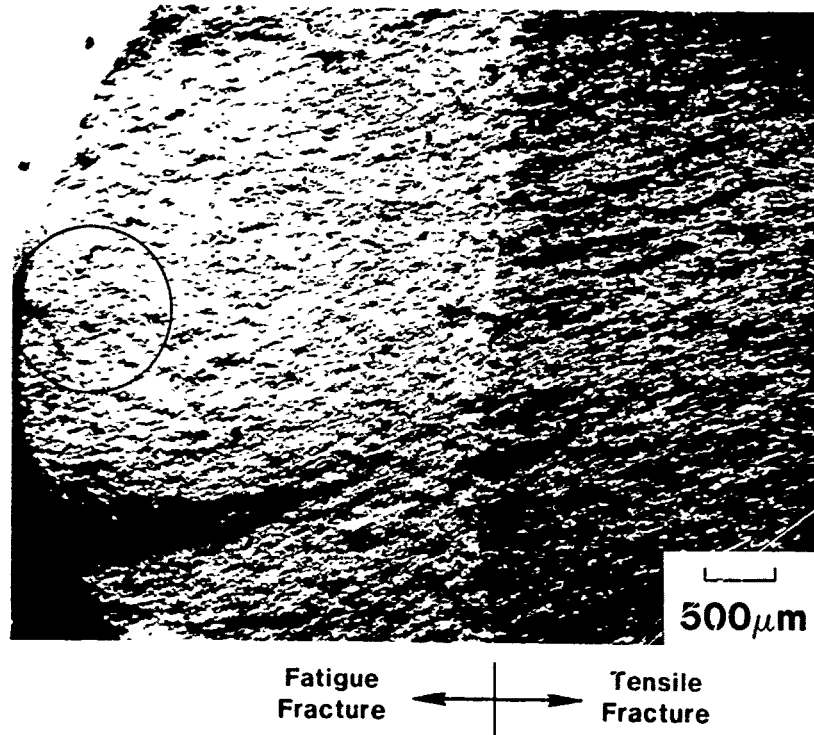
Figure 20

(a) SEM fractograph of a fracture surface (partial)  
of notched axial-stress fatigue specimen 504440-L-1  
(Al -3.1Cu -2.2Li - 1 Mg alloy T651 plate)

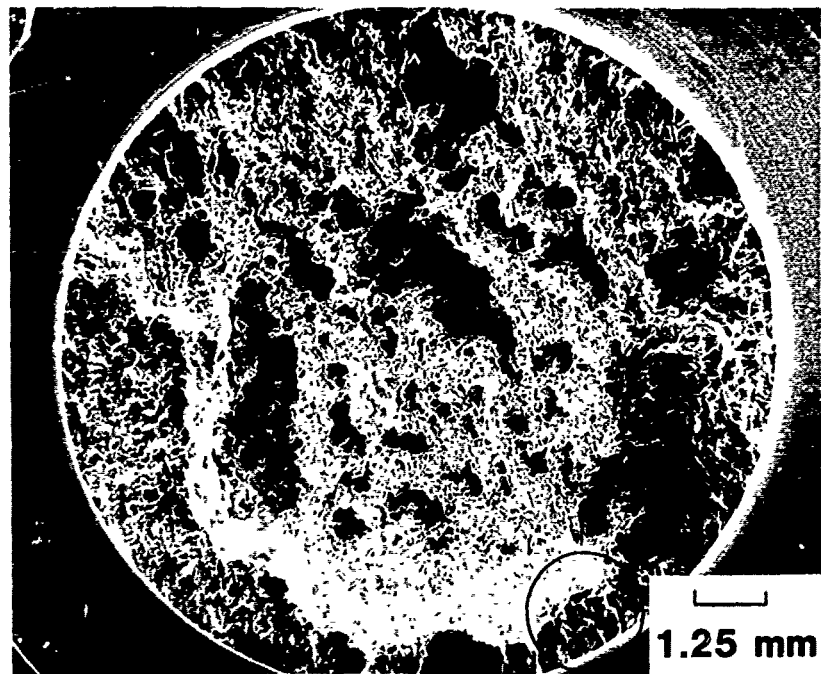
Figure 21

(a) SEM fractograph of a fracture surface of notched axial-stress fatigue specimen 523713-B-2-L-14 (2020-T651 plate)

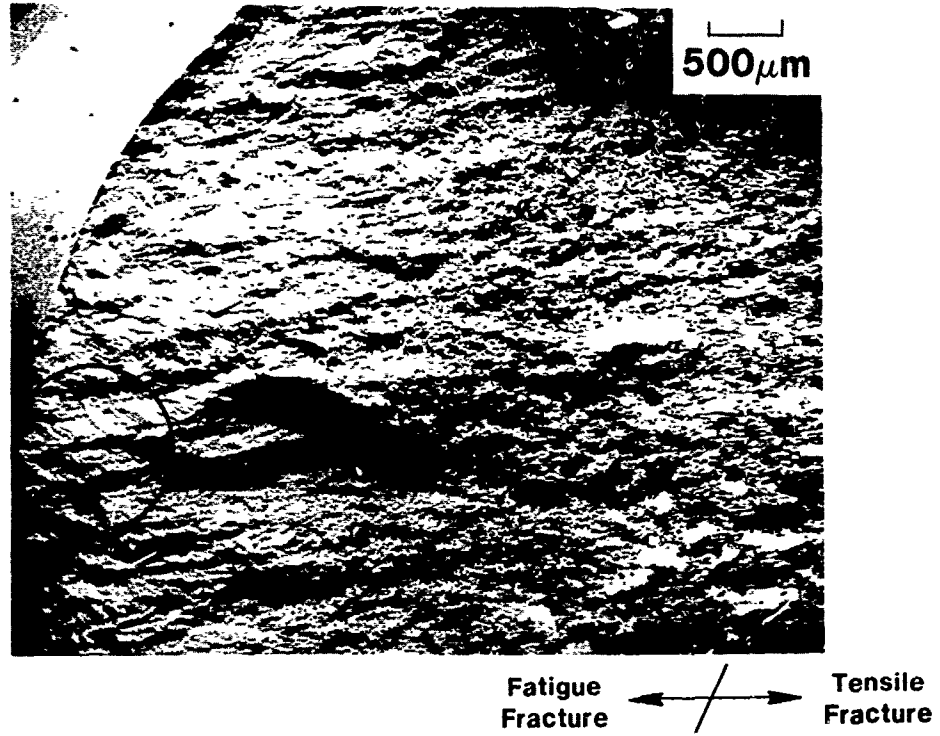
Figure 22

(a) SEM fractograph of a fracture surface (partial)  
of notched axial-stress fatigue specimen 523713-X-L-9  
(TMP 2020-T651 plate)

(b) SEM fractograph of fracture surface within circled area  
shown in (a)

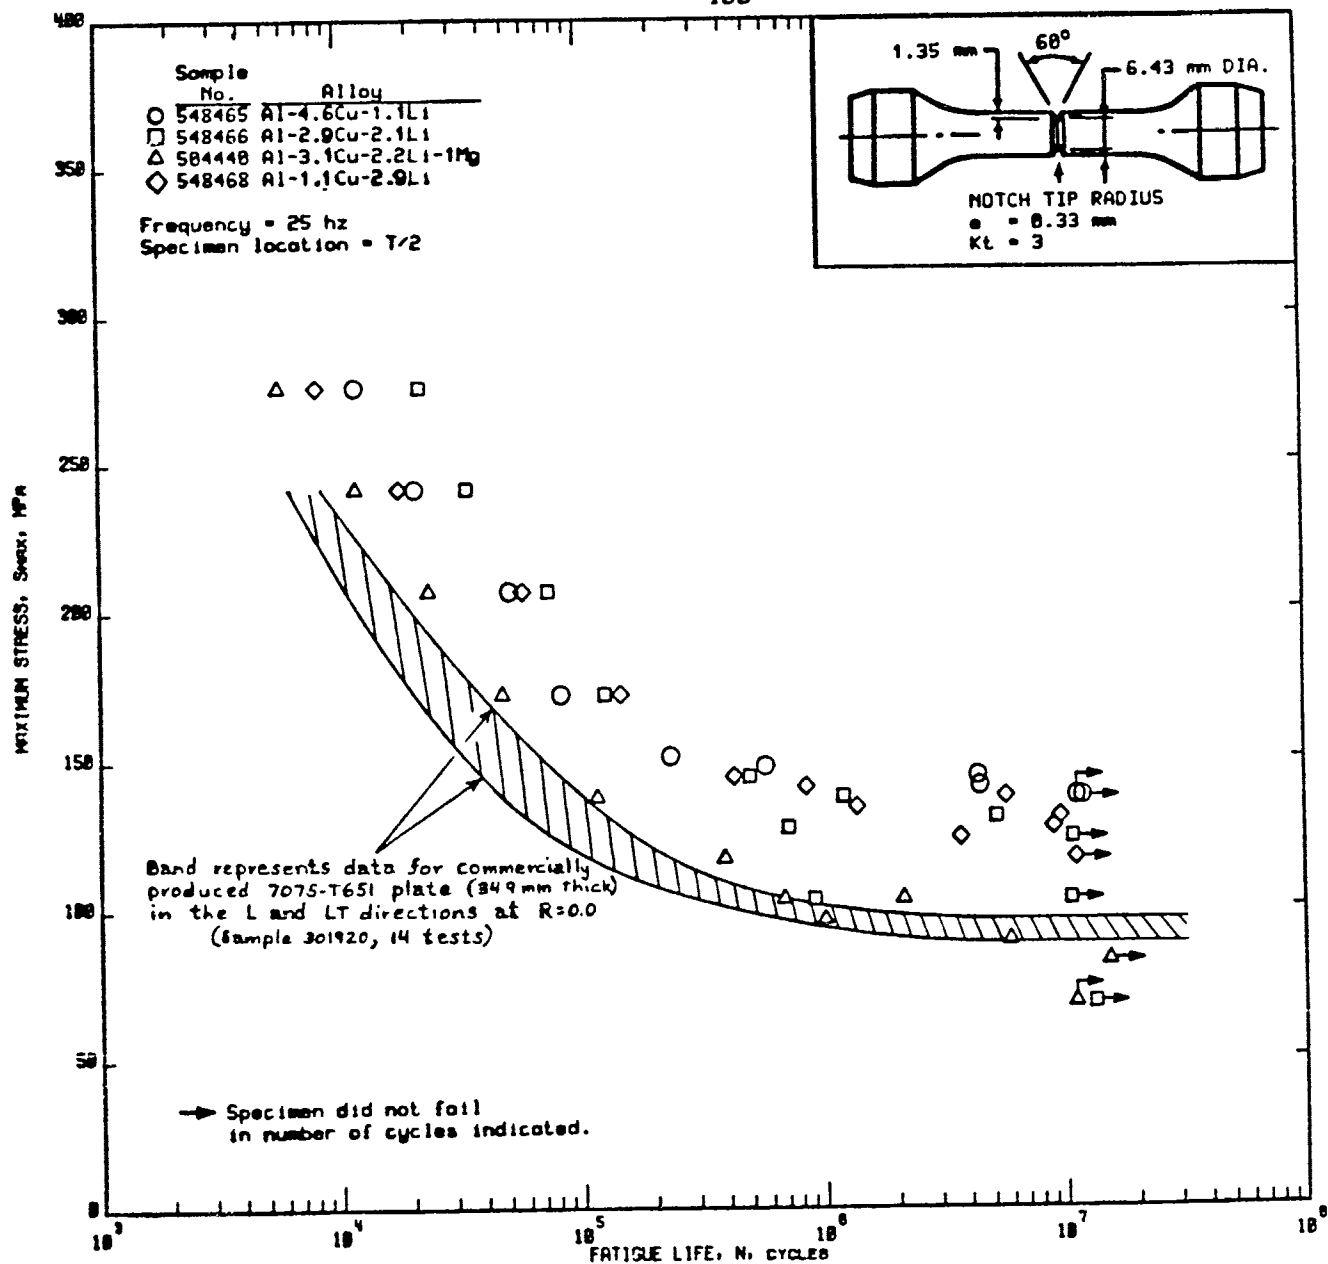
Figure 24

COMPARISON OF NOTCH ( $K_t=3$ ) AXIAL-STRESS FATIGUE (S-N) DATA FOR LABORATORY FABRICATED ALUMINUM ALLOYS (4.6Cu-1.1Li)-T651, (2.9Cu-2.1Li)-T651, (1.1Cu-2.9Li)-T651, (3.1Cu-2.2Li-1.0Mg)-T651 PLATE (12.7 MM THICK), R-RATIO=+0.1, AMBIENT AIR, L DIR.

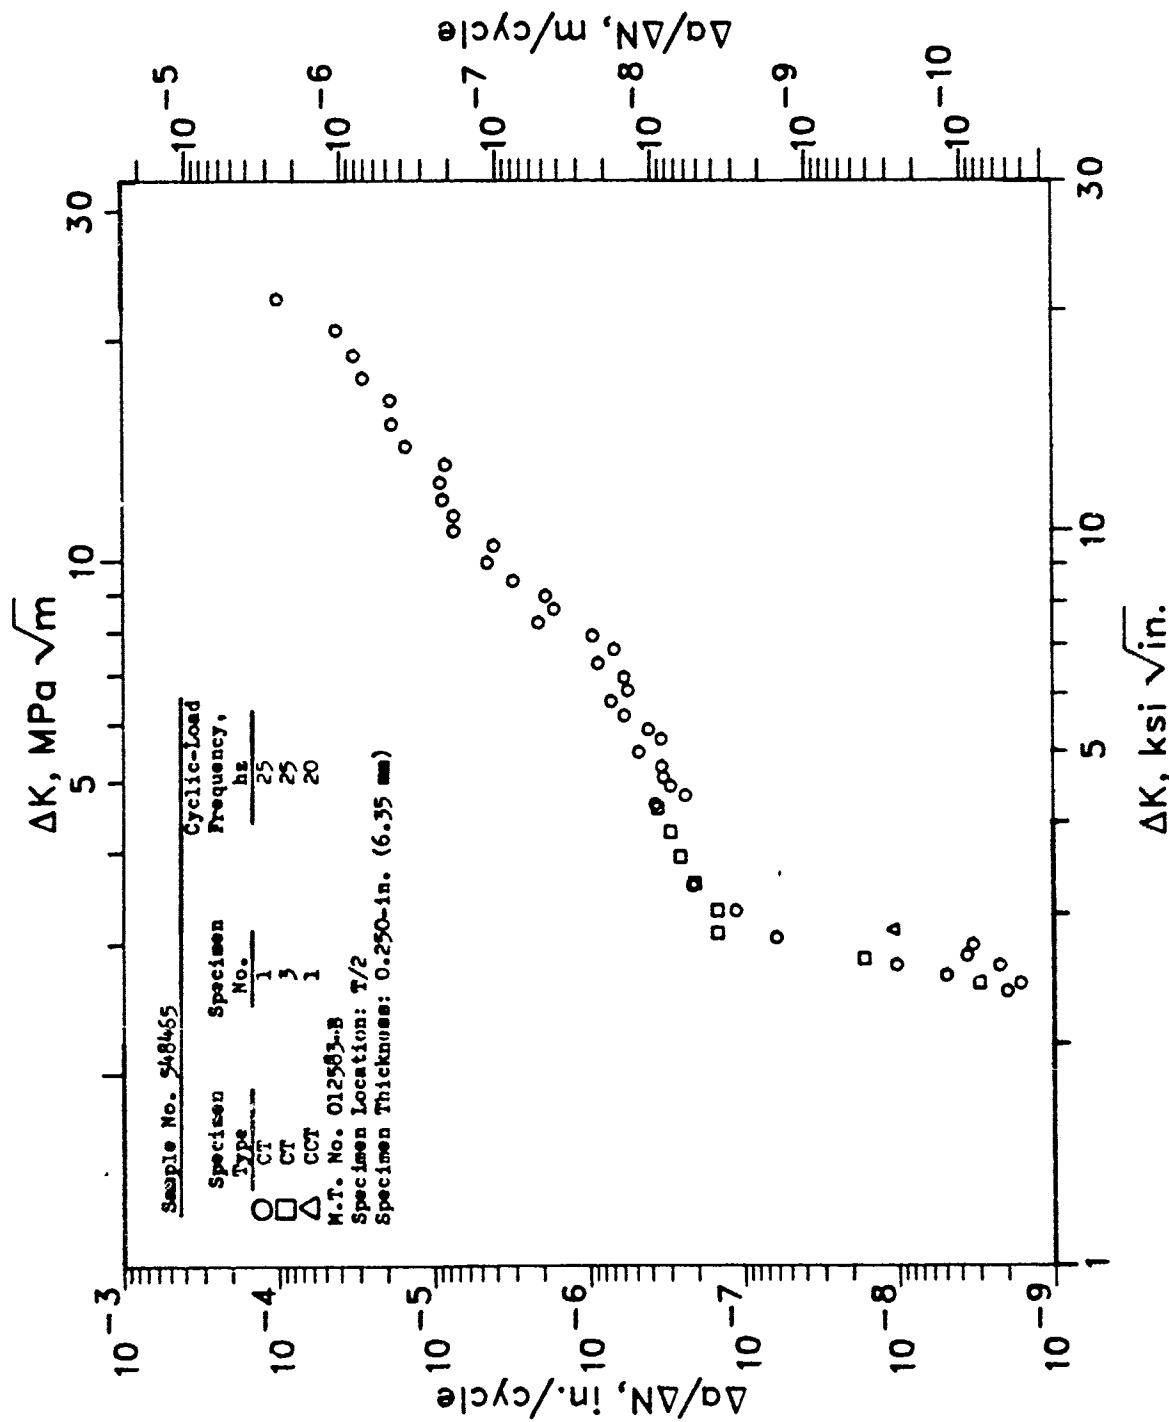
Constant-Load-Amplitude Fatigue Crack Propagation Data for  
Laboratory Fabricated Aluminum Alloy (4.6 Cu - 1.1 Li) - T651 Plate, 0.5-in. (12.7mm) thick  
L-T orientation, R-Ratio = +0.33, High Humidity (R.H. > 90%) Air

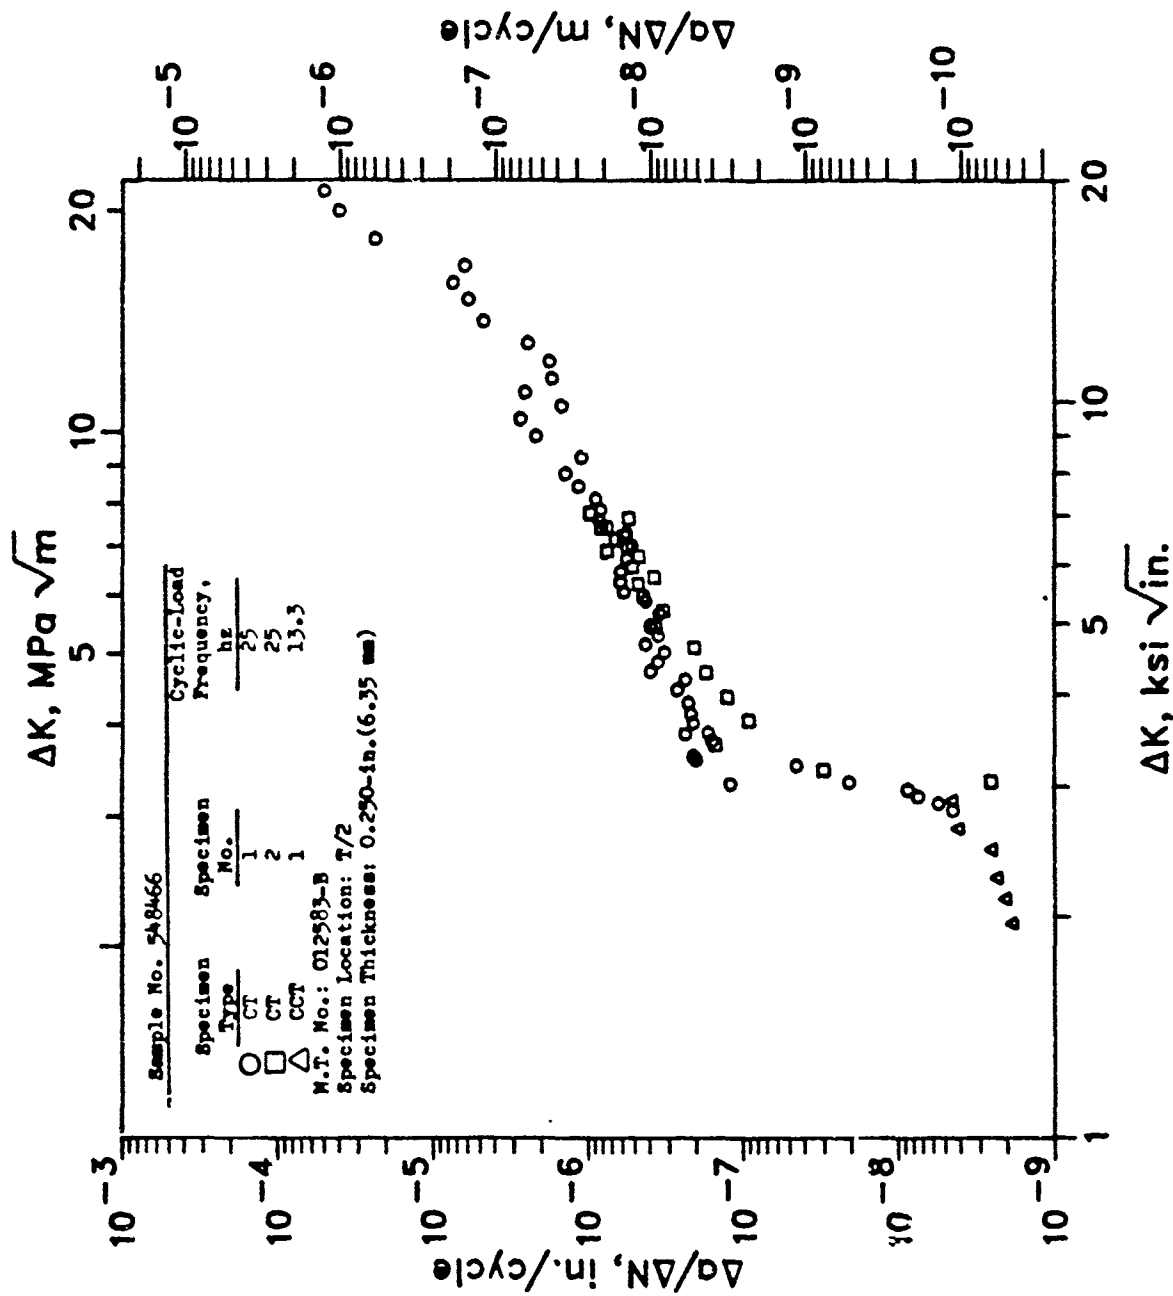
Constant-Load-Amplitude Fatigue Crack Propagation Data for  
 Laboratory Fabricated Aluminum Alloy (2.9 Cu - 2.1 Li) - T651 Plate, 0.5-in. (12.7 mm) thick  
 L-T orientation, R-Ratio = +0.33, High Humidity (R.H. > 90%) Air

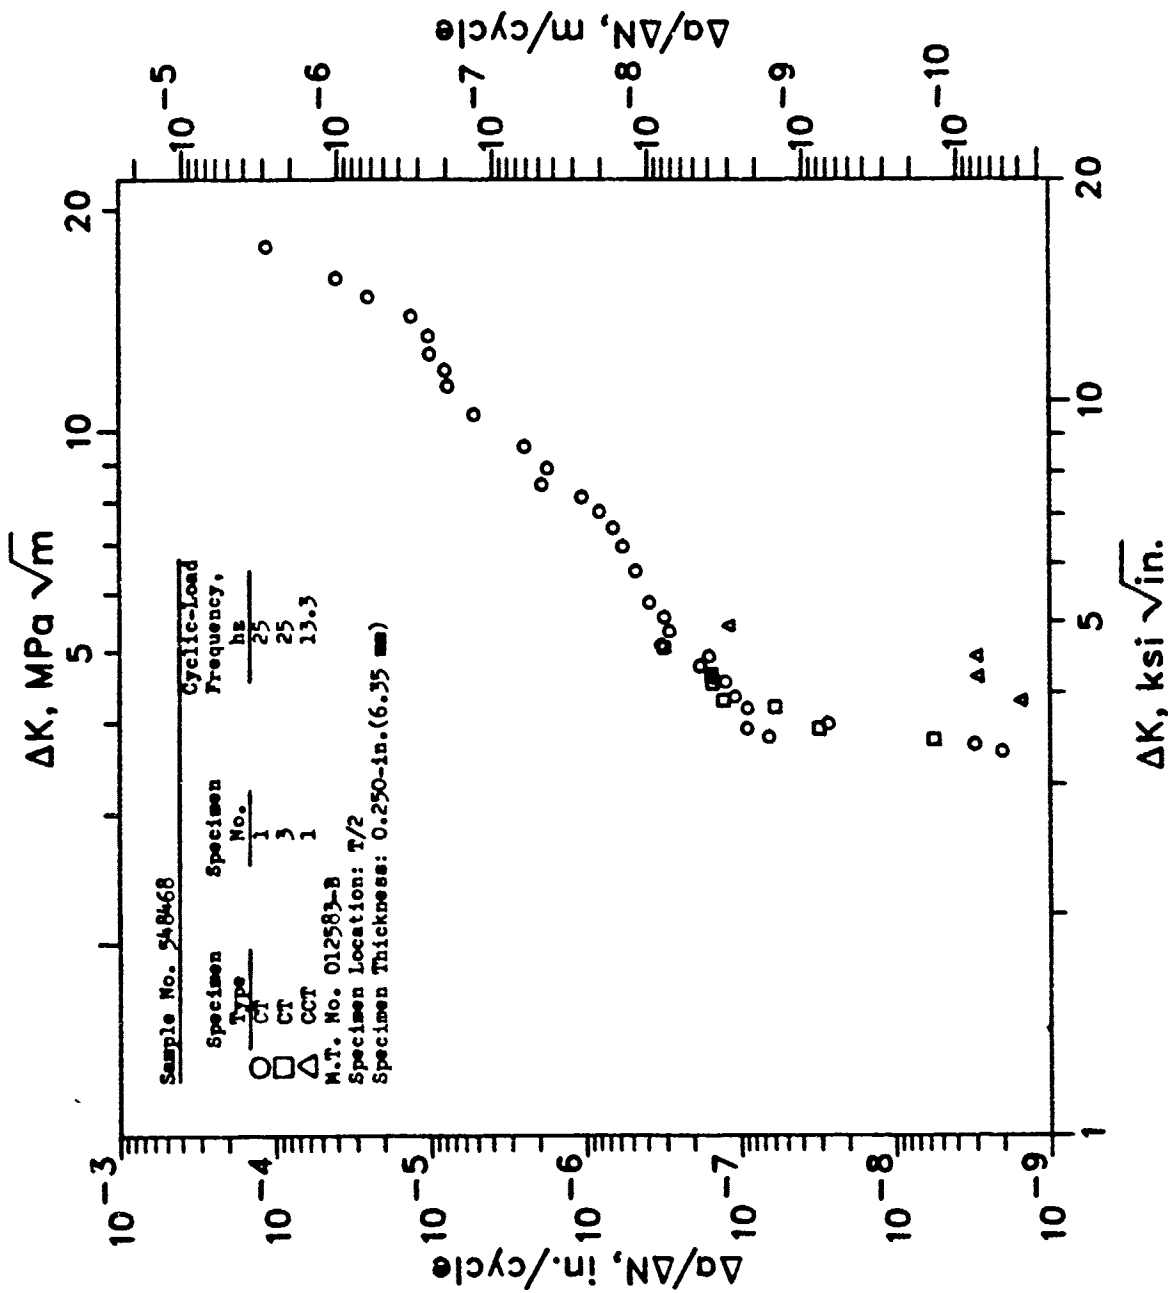
Constant-Load-Amplitude Fatigue Crack Propagation Data for  
Laboratory Fabricated Aluminum Alloy (1.1Cu-2.9Li)-T651 Plate, 0.5-in. (12.7 mm) thick  
L-T orientation, R-ratio = +0.33, High Humidity (R.H. > 90%) Air

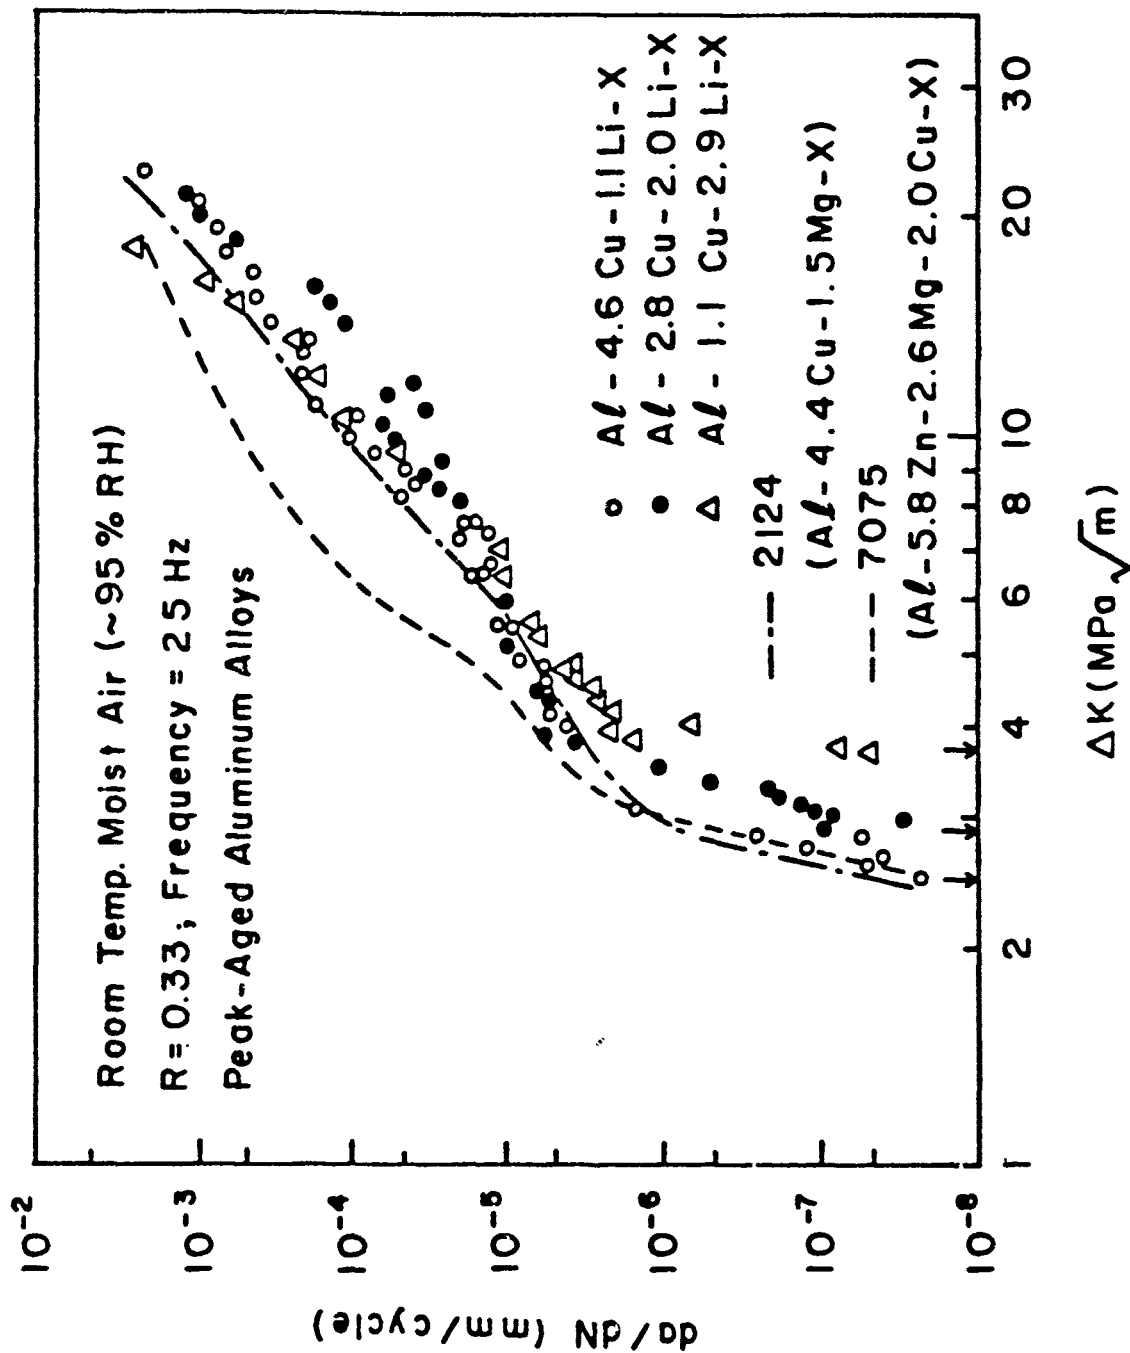
Comparison of the constant-load-amplitude FCG data of the three Al-Cu-Li-Zr alloys investigated. The dashed lines indicate FCG behavior of peak-aged alloys 2124 and 7075.

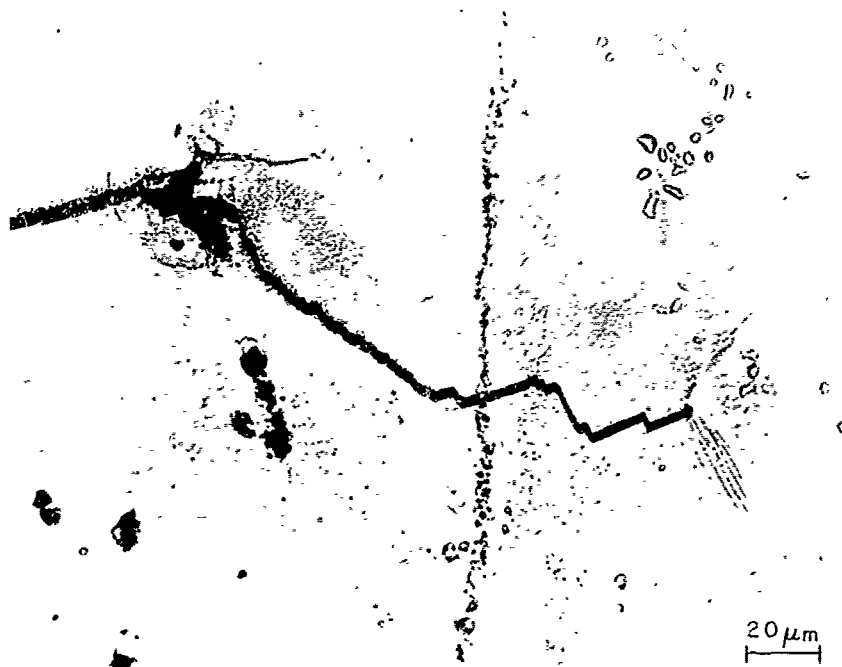
Figure 31

Fatigue crack profile for alloy Al-2.9Cu-2.1Li (range of  $\Delta K \sim 3.0-8 \text{ MPa}\sqrt{\text{m}}$ ).

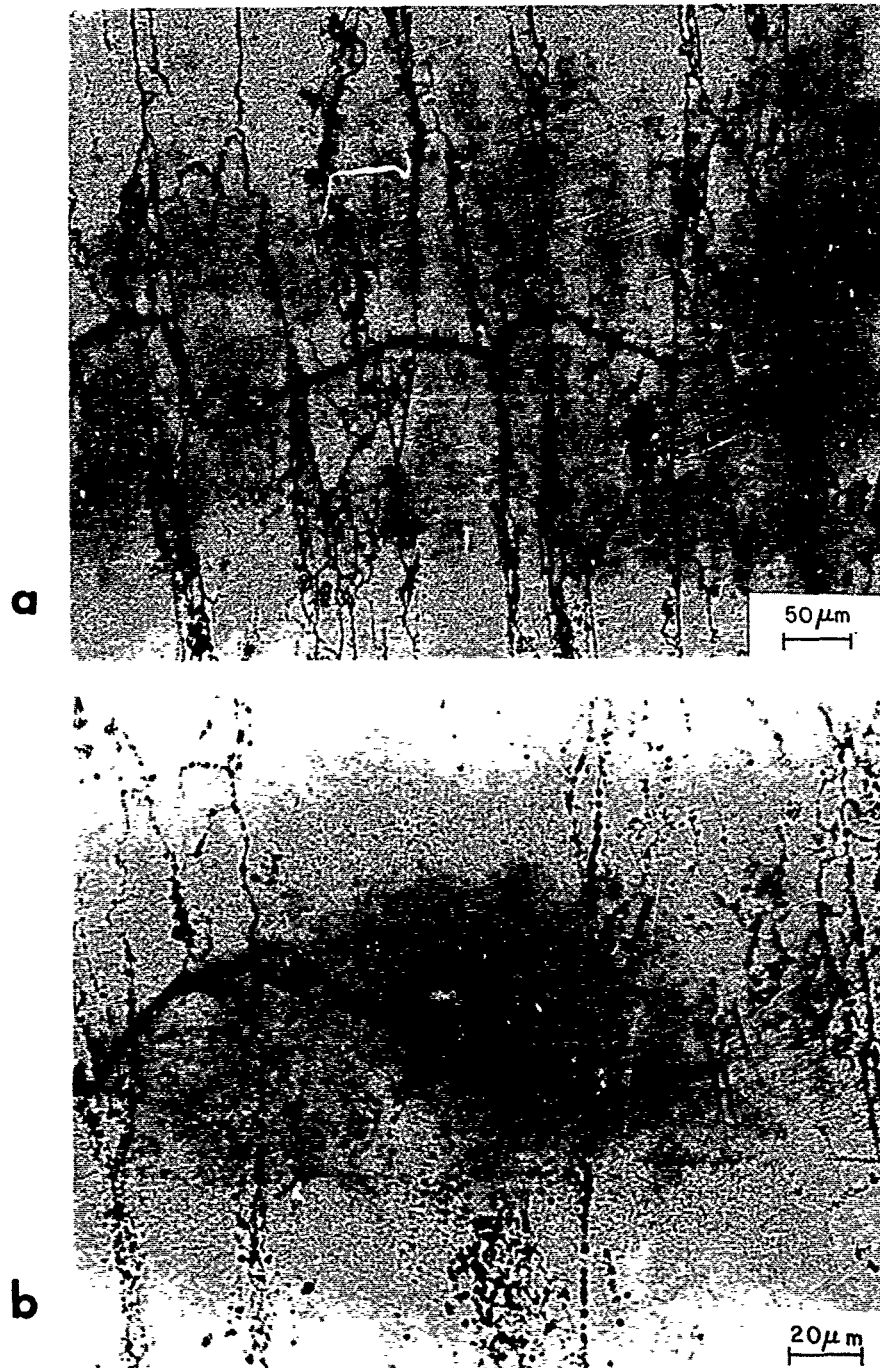
Figure 32

Fatigue crack profile for alloy Al-1.1Cu-2.9Li (range of  $\Delta K \sim 5.8-8 \text{ MPa}\sqrt{\text{m}}$ )

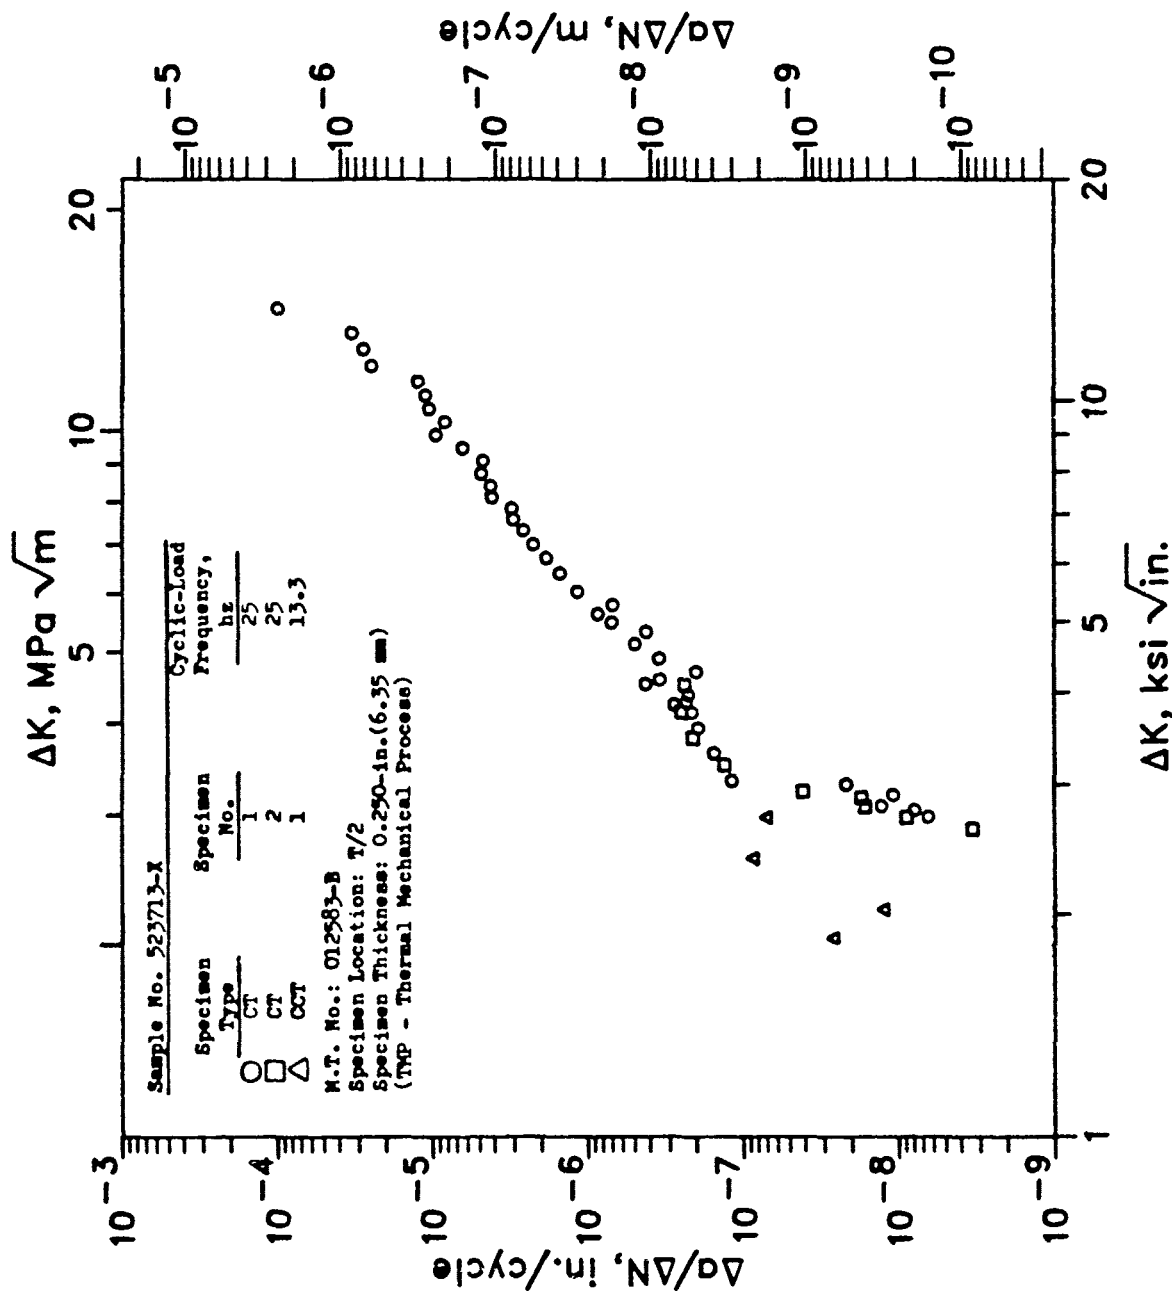
Figure 33

Constant-Load-Amplitude Fatigue Crack Propagation Data for Laboratory Fabricated Aluminum Alloy 2020-T651 Plate (Unrecrystallized through TMP) 0.5-in. (12.7 mm) thick, L-T orientation, R-Ratio = +0.33, High Humidity (R.H.>90%) Air

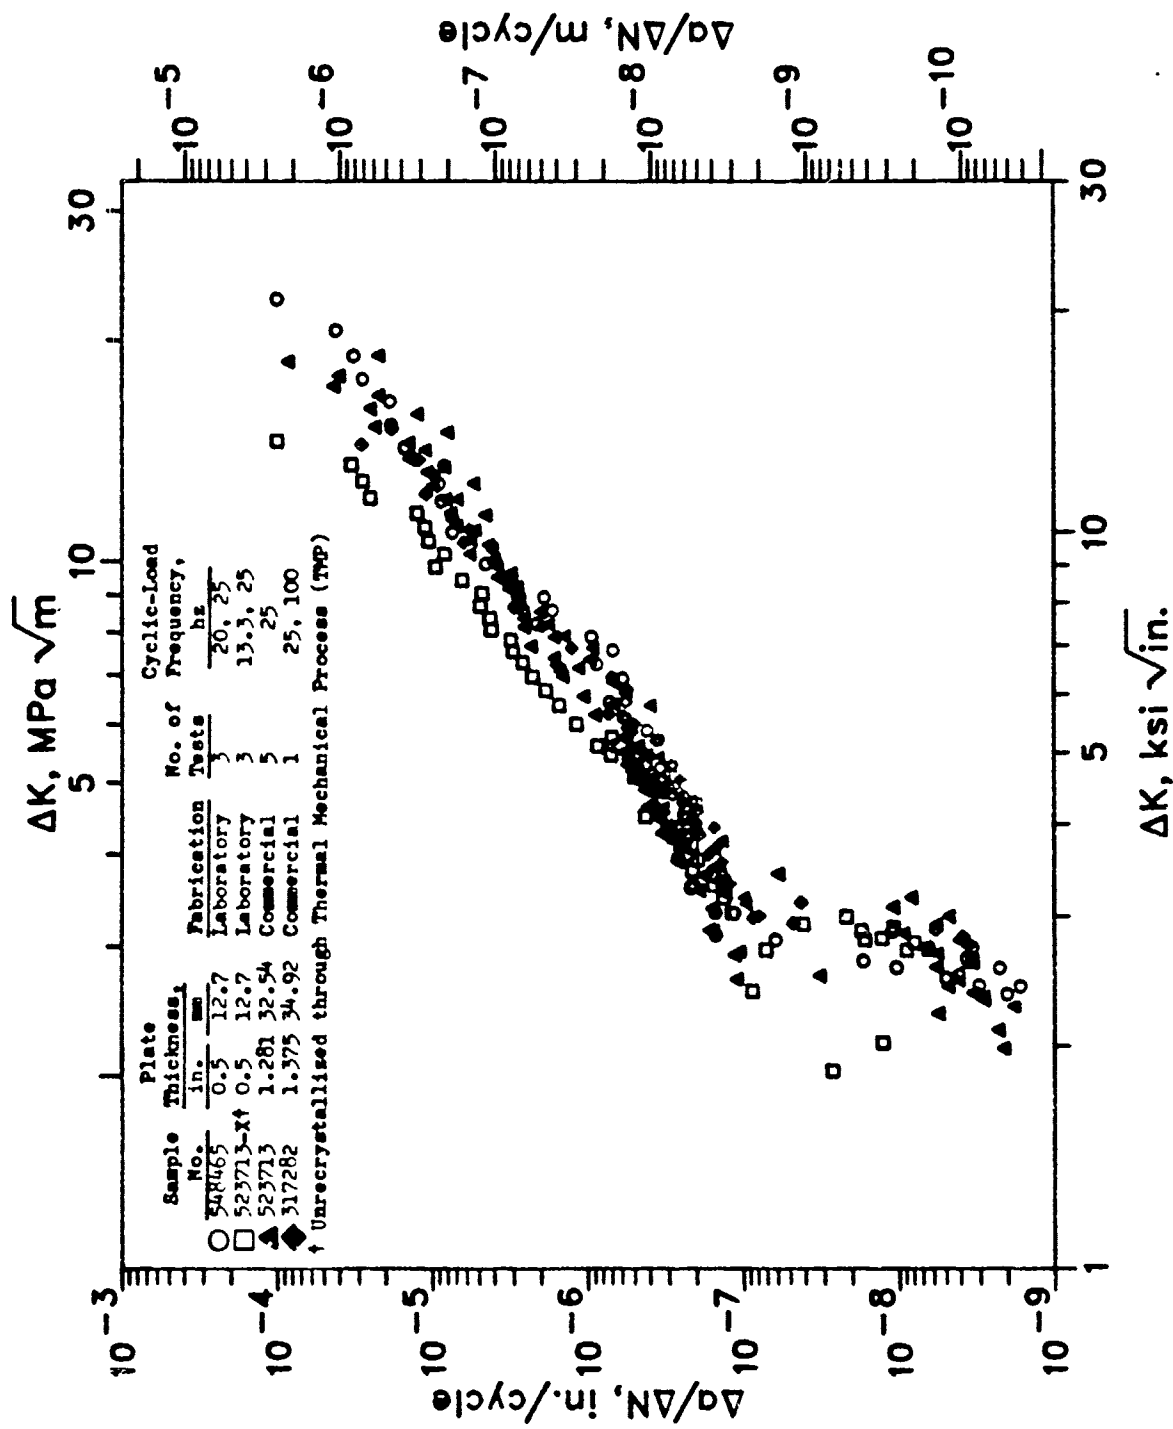
Comparison of Constant-Load-Amplitude Fatigue Crack Growth Data for  
 Four Samples of Aluminum Alloy 2020-T651 Plate  
 (two laboratory fabricated and two commercially produced)  
 L-† orientation, R-Ratio = +0.33, High Humidity (R.H.>90%) Air

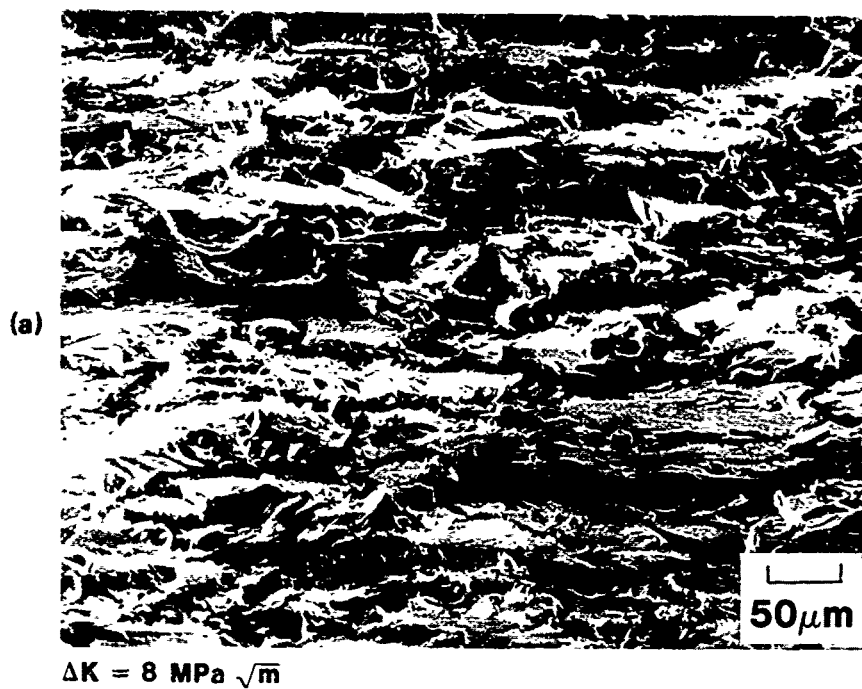
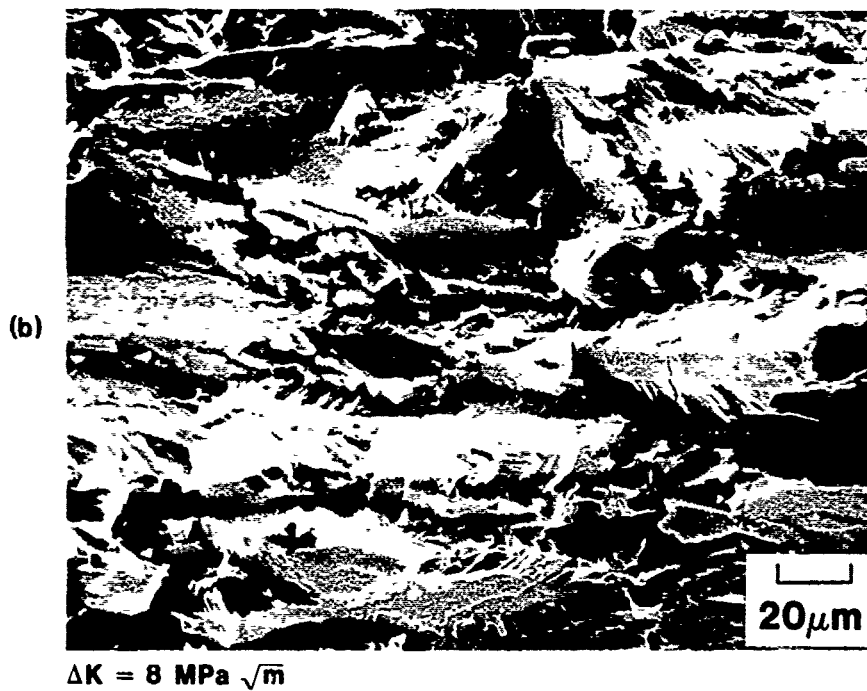
Figure 38

SEM fractographs of CA fracture surface of CT  
FCG specimen 548468-L-T-1 (Al -1.1Cu -2.9Li alloy T651  
plate) at  $\Delta K = 8 \text{ MPa } \sqrt{\text{m}}$

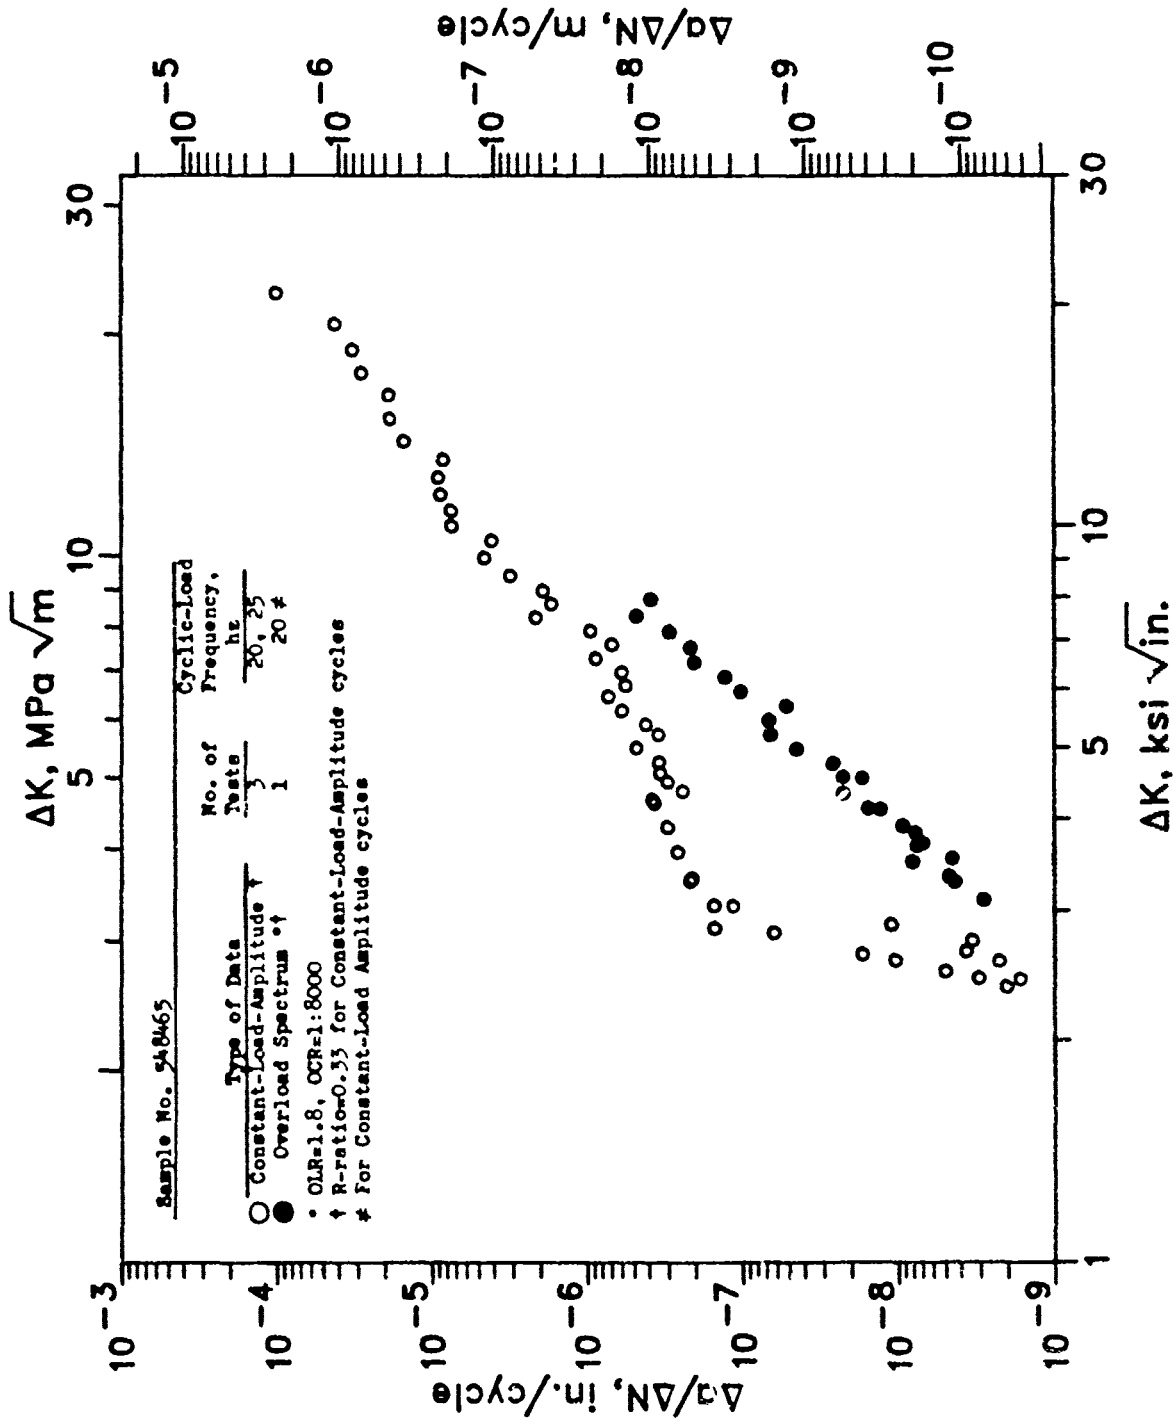
Figure 40

Comparison of Constant-Load-Amplitude and Overload Spectrum Fatigue Crack Growth Data for Laboratory Fabricated Aluminum Alloy (4.6 Cu - 1.1 Li) - T651 Plate, 0.5-in. (12.7 mm) thick L-T orientation, High Humidity (R.H.>90%) Air

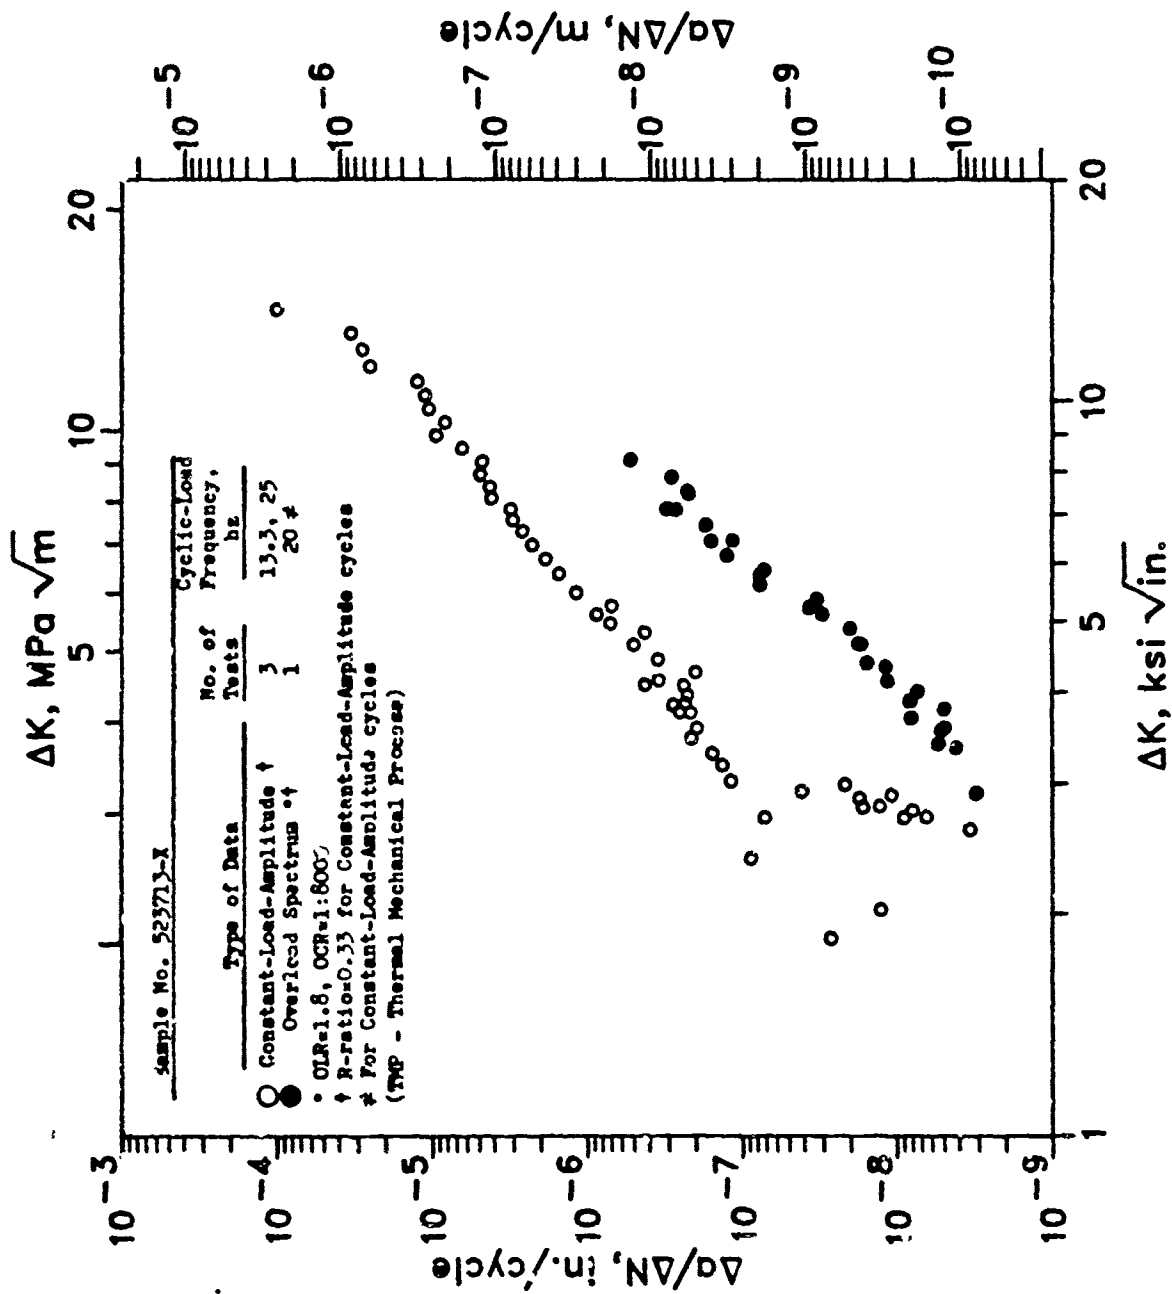
Comparison of Constant-Load-Amplitude and Overload Spectrum Fatigue Crack Growth Data for Laboratory Fabricated Aluminum Alloy 2020-T651 Plate (Unrecrystallized through TMP), 0.5-in. (12.7 mm) thick

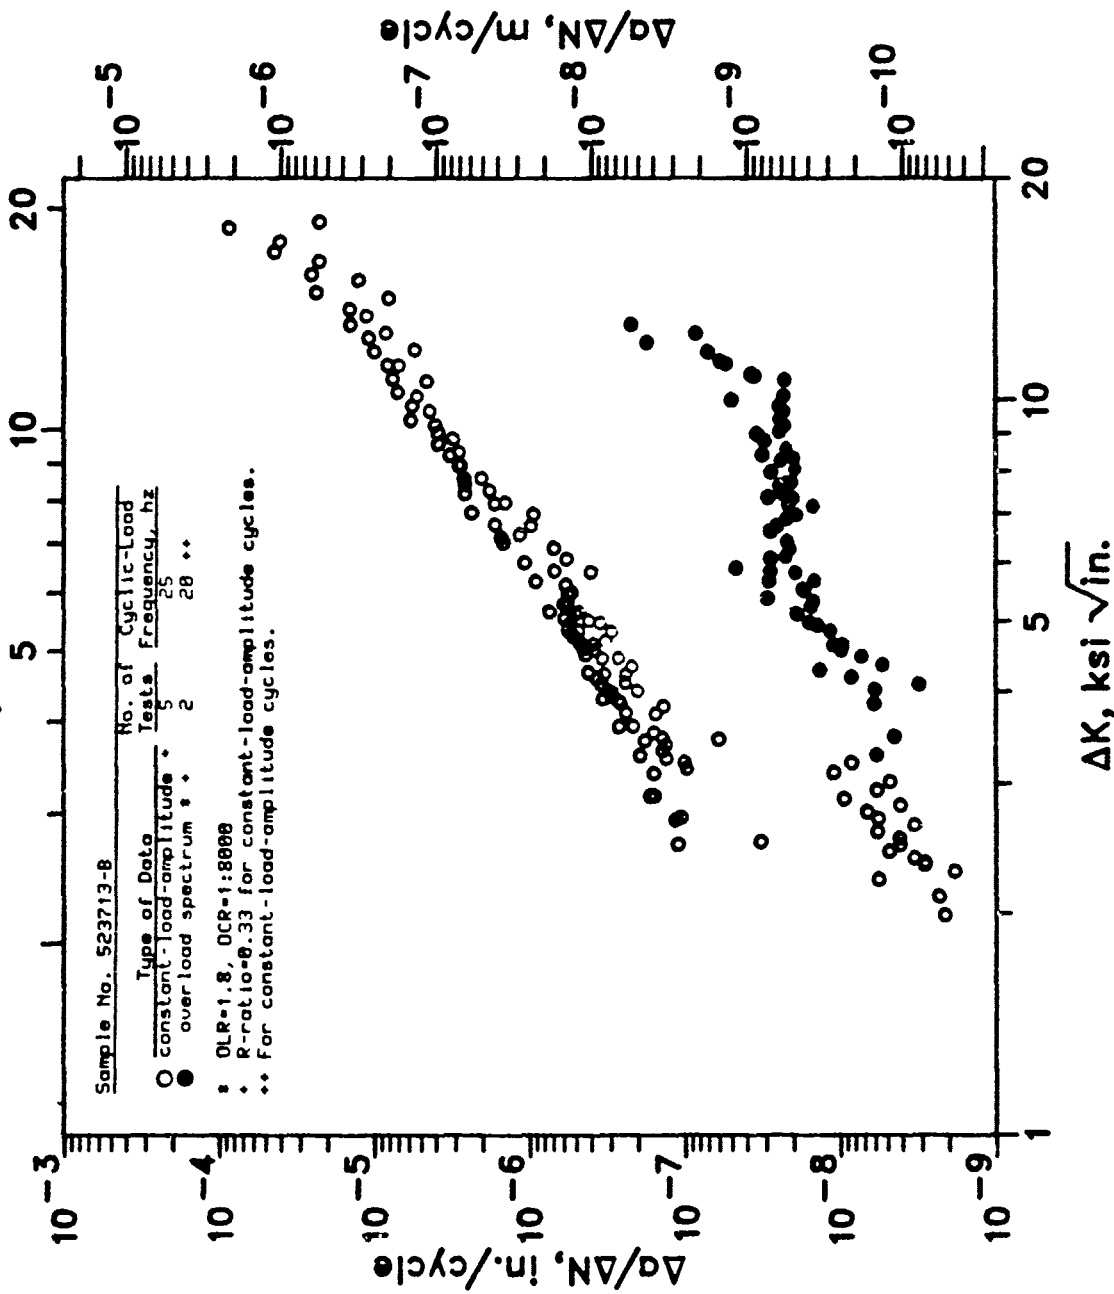
Comparison of Constant-Load-Amplitude and Overload Spectrum  
 Fatigue Crack Growth Data for Commercially Produced Aluminum Alloy  
 2020-T651 Plate, 1.281-in. (32.54 mm) thick  
 L-T orientation, high humidity (r.h.>90%) air
